<b>Product:</b> PLASMA TV	<b>Models:</b> TH42PX600 TH42PX60	<b>Number:</b> TT-08-15
<b>Code:</b> B62		<b>Date:</b> February 26, 2008
<b>Model Year:</b> 2006

**PCB Designation:** P Board

**Part #:** TXN/P1BFTUS & TXN/P1BJTUS

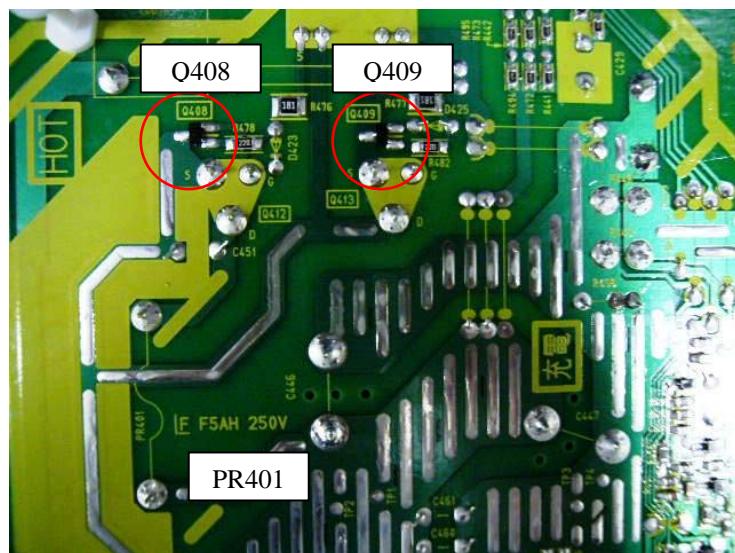
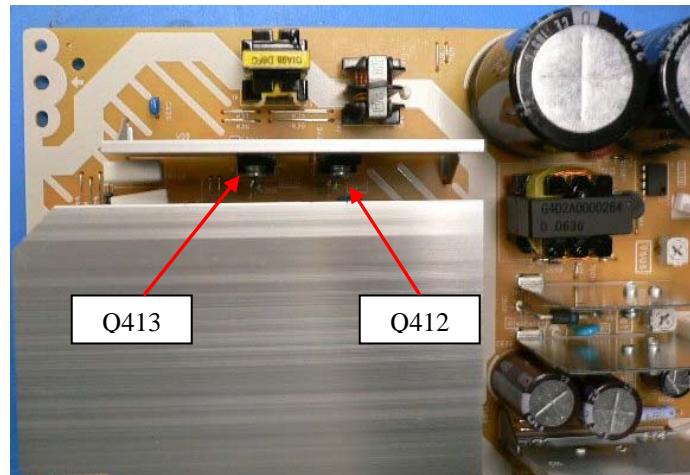
**Symptom:** Shuts down with power LED 10 blinks.

**Cause:** Missing 395Vdc output due to shorted Q412 & Q413 and open PR401.

**Remedy:** Replace Q412, Q413, PR401 & check/replace Q408 and Q409.

Note: Always confirm condition of Q408 & Q409, in some cases could be shorted.
